## FACILITY STATUS CHANGE FORM

<b>Date Submitted:</b> Jan 30, 2013 <b>Originator:</b> David Warren <b>Phone:</b> 539-6040	<b>Area:</b> 100-N <b>Facility ID:</b> 1303-N Spacer Silos <b>Action Memorandum:</b> 100-N Ancillary Facilities	<b>Control #:</b> D4-100N-0049
---	--	-----------------------------------

## D4 Project Facility Completion Form

# 100-N ANCILLARY FACILITIES REMOVAL ACTION SAMPLING DETERMINATION FORM

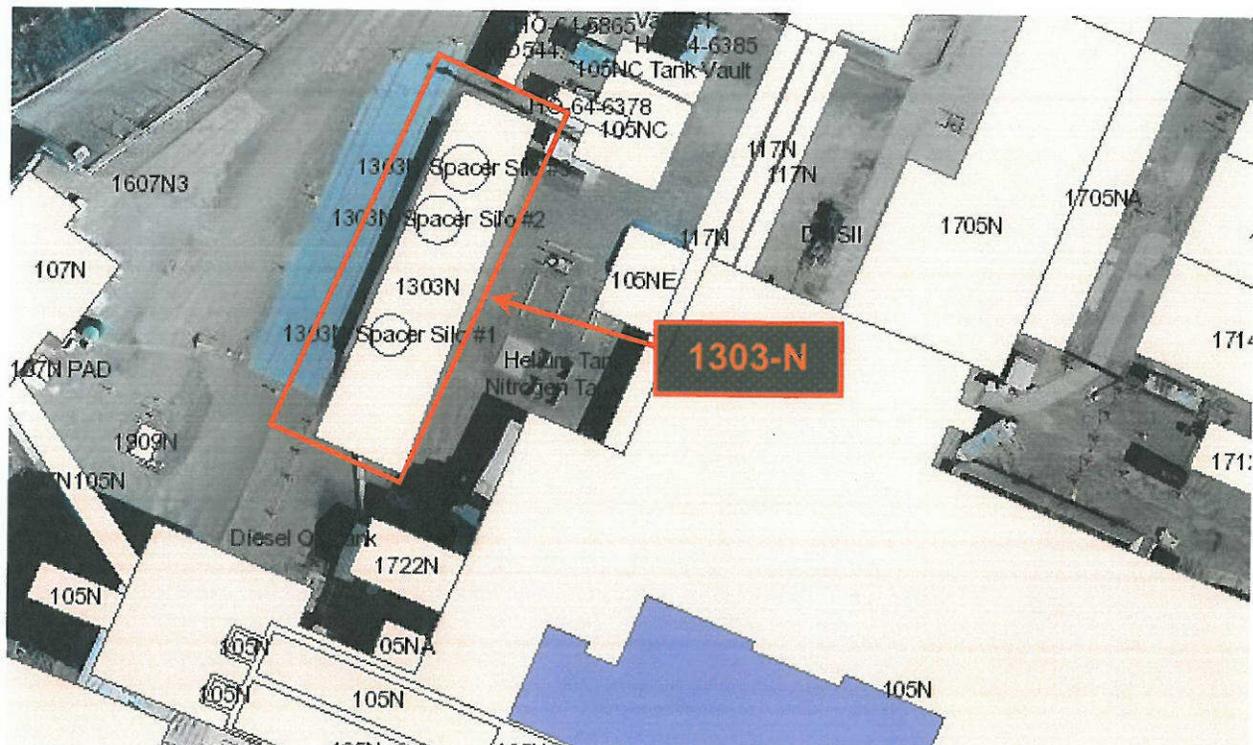
**Figure 1: Location of the 1303-N Spacer Silos**

The silos, two of which were open to the underlying soil, were used for temporary storage of spent irradiated fuel rod spacers. The spacers were transferred from the fuel storage basin of the 105-N Reactor to the silos, where they would remain until they were removed and transported to the 200 Area burial grounds for permanent disposal. The last spacers were removed from the silos in September of 1995. The footprint of the 1303-N Spacer Silos has been incorporated into Waste Information Data System (WIDS) site 118-N-1. A map of the 1303-N Spacer Silos is included in Figure 1. Photographs are included in Attachment 2.

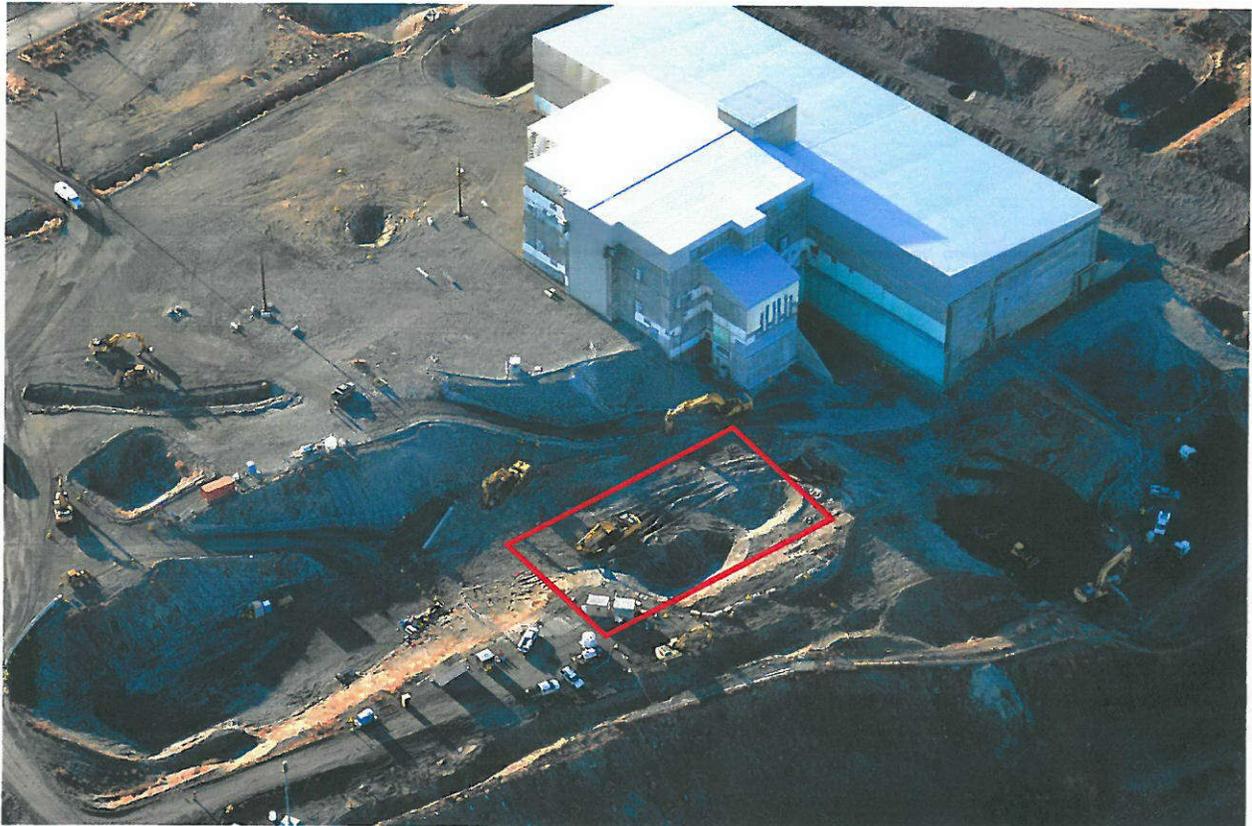
**1303-N Post-Demolition (October 2012)**

The above-grade and below-grade portions of the 1303-N Spacer Silos have been demolished, excavated, and disposed at the ERDF. With the exception of 118-N-1, all Waste Information Data System (WIDS) sites within the excavation boundary were removed. No anomaly was encountered during demolition.

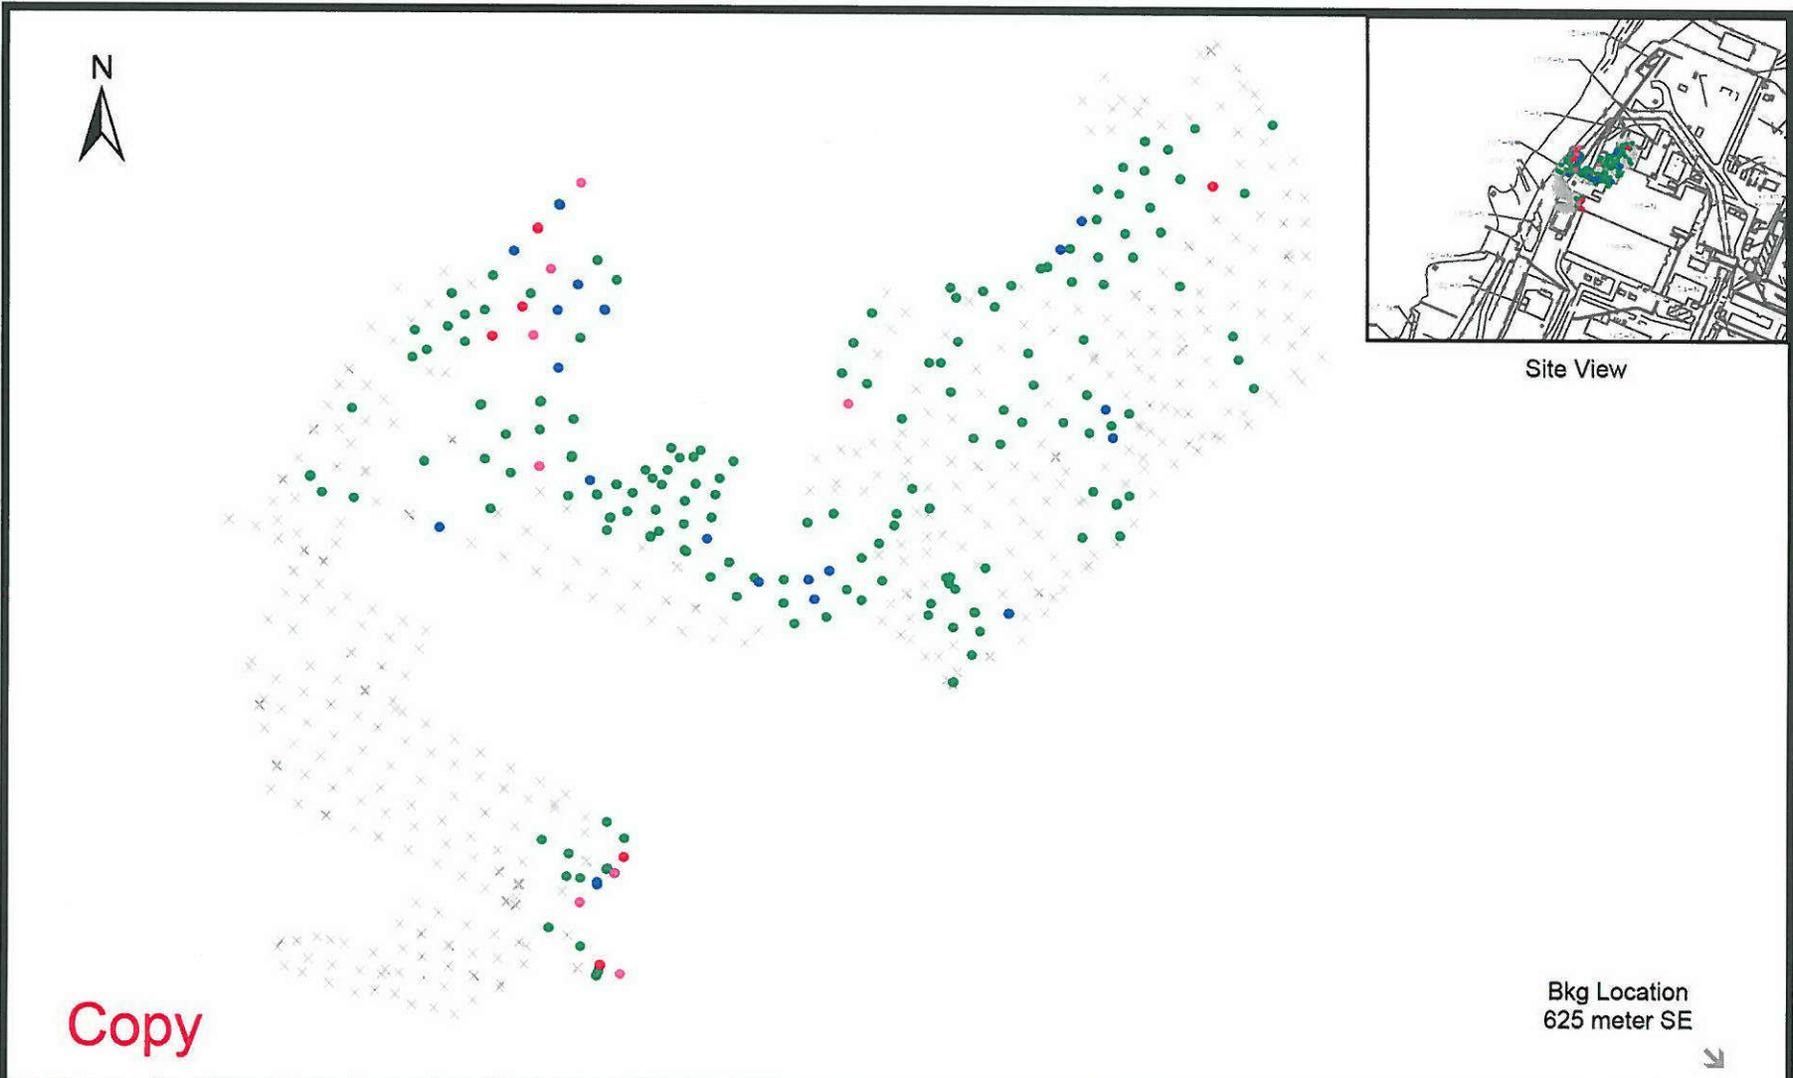
**100N D4**  
**1303-N Work Zones**  
**GPERS Radiological Survey**  
**Beta Track Map**

Post-demolition Global Positioning Environmental Radiological Surveyor (GPERS) surveys were performed at the 1303-N Spacer Silos in December of 2012. Residual radiological contamination was detected during these surveys. The GPERS survey maps are included in Attachment 3 and are summarized in Table 1 below.

Type	Quantity	Method Detection Limits	Results
GPERS Surveys	2 Surveys	N/A	<p>A total of 9,369 data points were taken at the soil within, and within the vicinity of, the 1303-N facility footprint. Multiple data points were found to exceed 1.5 times the background radiological count. It should be noted that readings from this location that do not exceed 1.5 times the background count are considered to be insignificant.</p> <p>The GPERS survey maps are included in Attachment 3.</p>

Legend	Summary Statistics
NET CPM	Coverage File: N, NN349, A, B, C
X <1.5x Bkg	Number of Data Pnts: 652
● 1.5x Bkg - 5000	Type of Survey: beta
● 5000 - 10000	Max GCPM: 139,217
● 10000 - 25000	Avg Bkg CPM: 401
● 25000	Survey Date: 12/14/2012
	Area Surveyed: 2250 m <sup>2</sup>
	Project File: ESRFRM120150B
	Pdf File: ESRFRM120150BC

The post-demolition GPERS surveys performed within the historical footprint of the 1303-N Spacer Silos identified radiological contamination within the remaining soil. The entire footprint of the 1303-N Spacer Silos has been incorporated into WIDS site 118-N-1, and accordingly, the contamination remaining within the historical facility footprint will be addressed during activities performed for closeout of this WIDS site. These activities will be performed by the Field Remediation organization.

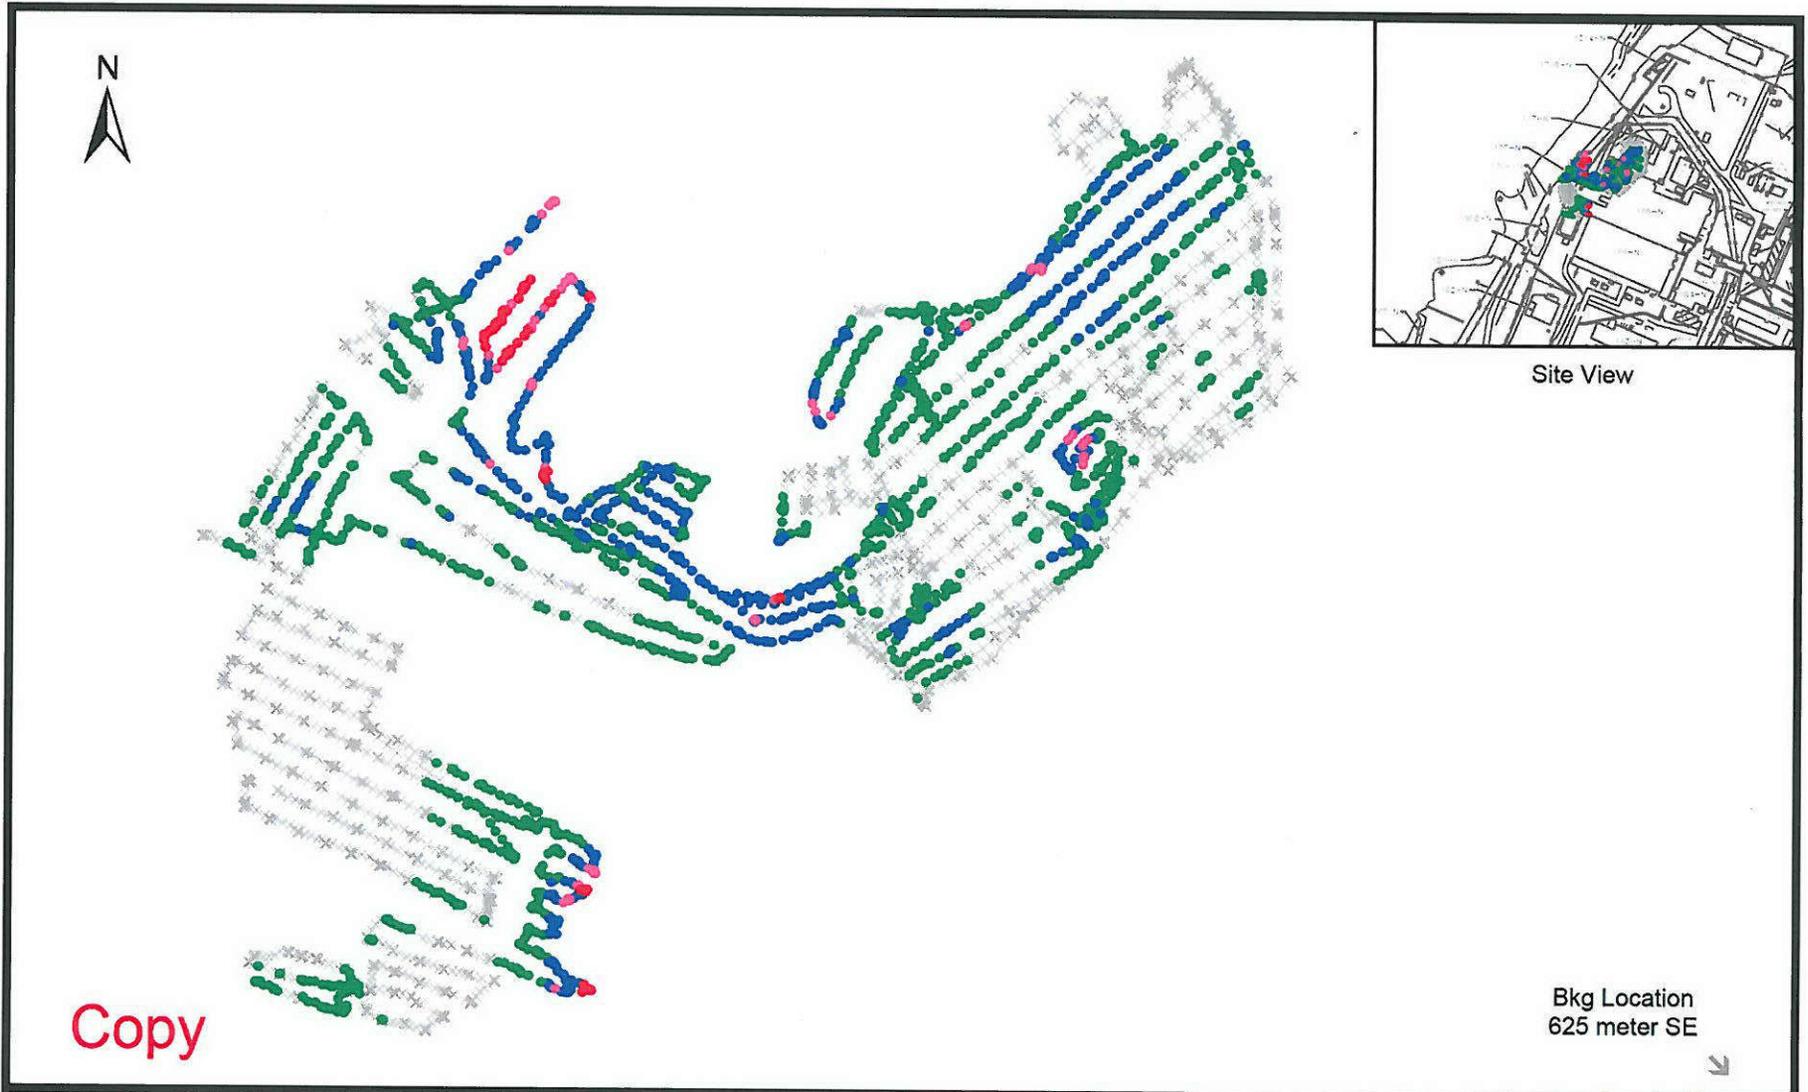
# 100N D4 1303-N Work Zones GPERS Radiological Survey Gamma Track Map

Legend	Summary Statistics
NET CPM	Coverage File: N,NN349, A,B,C
× <1.5x Bkg	Number of Data Pnts: 8717
● 1.5x Bkg - 10000	Type of Survey: Gamma
● 10000 - 50000	Max GCPM: 680,272
● 50000 - 100000	Avg Bkg CPM: 1327
● >100000	Survey Date: 12/14/2012
	Area Surveyed: 2250 m <sup>2</sup>
	Project File: ESRFRM120150G
	Pdf File: ESRFRM120150GC

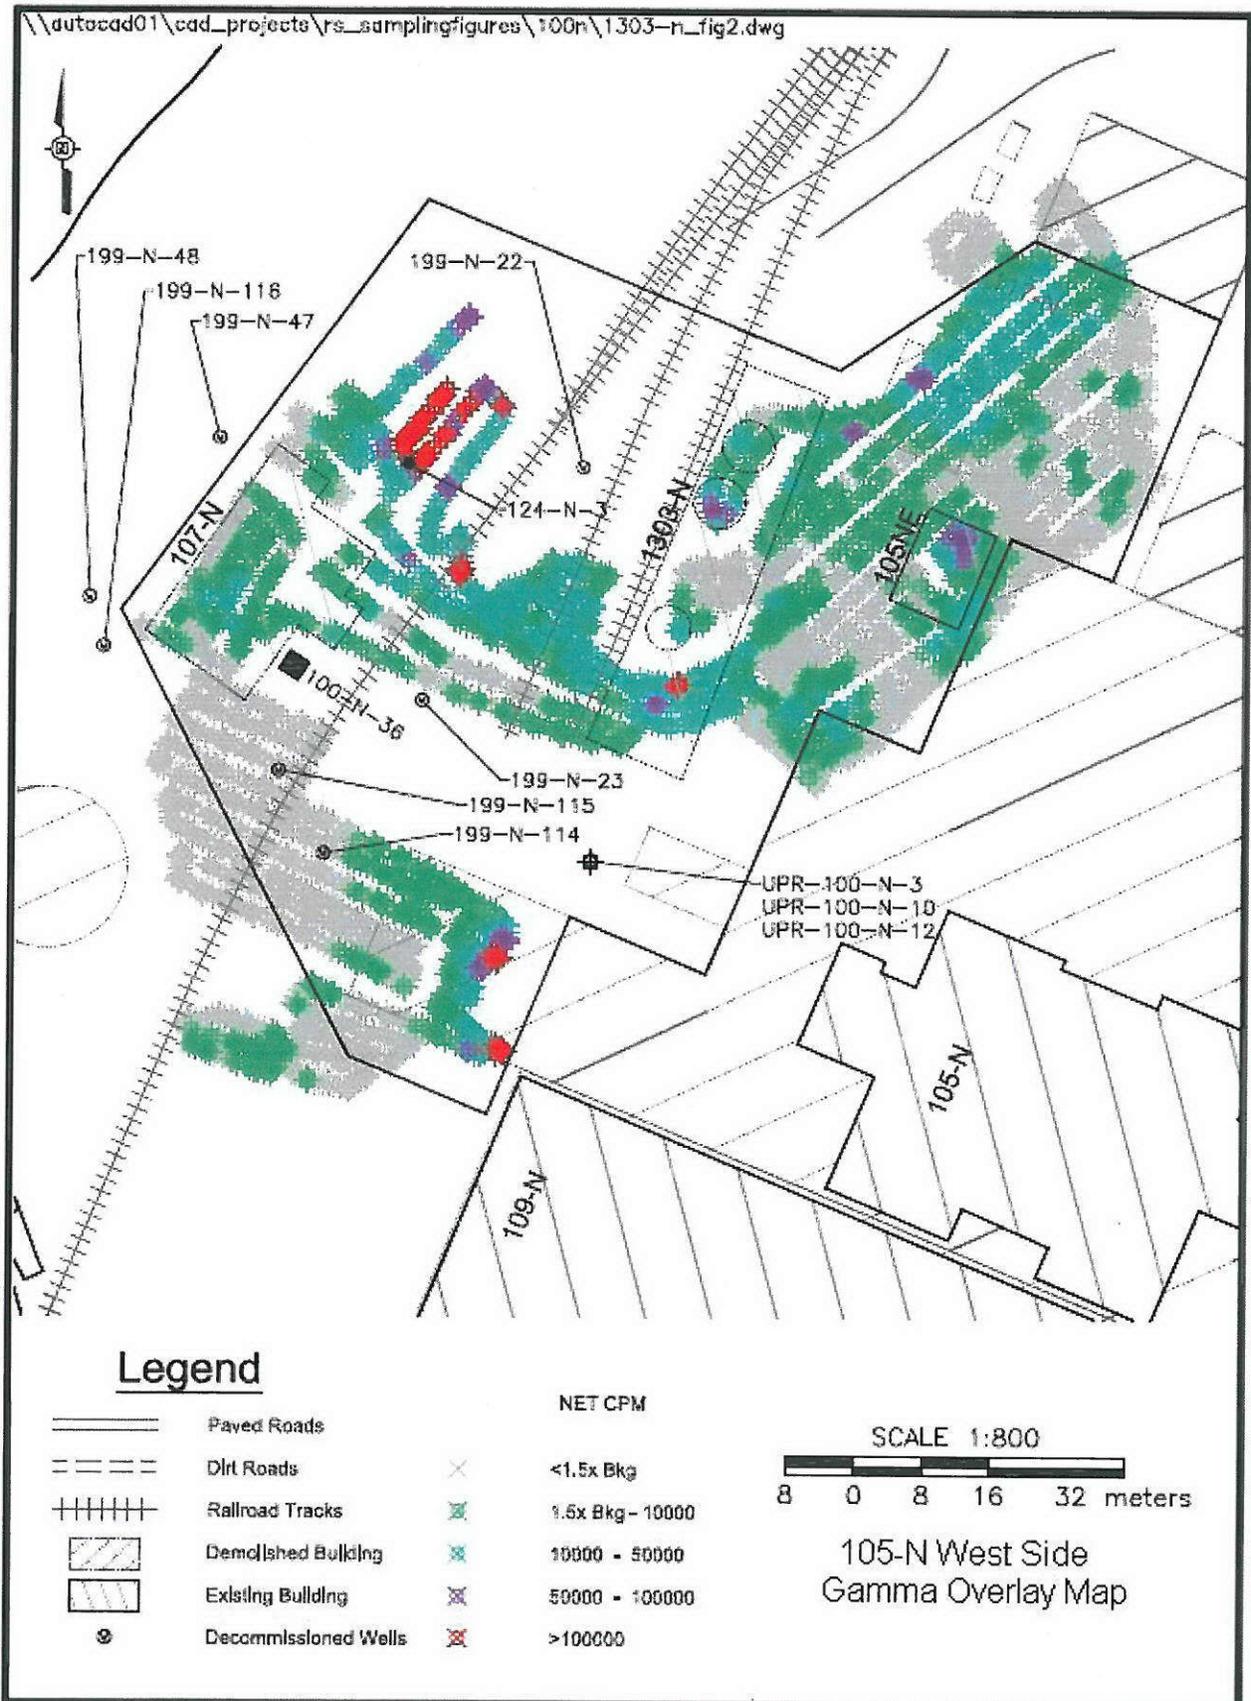
**GPERS Gamma Map Location Overlay (for reference purposes only)**

Post-demolition GPERS surveys identified elevated levels of radiological contamination within, and adjacent to, the 1303-N facility footprint (ESR-FRM-12-0150BC, ESR-FRM-12-0150GC, GPERS Beta Map Location Overlay [attached to this form], and GPERS Gamma Map Location Overlay [attached to this form]).

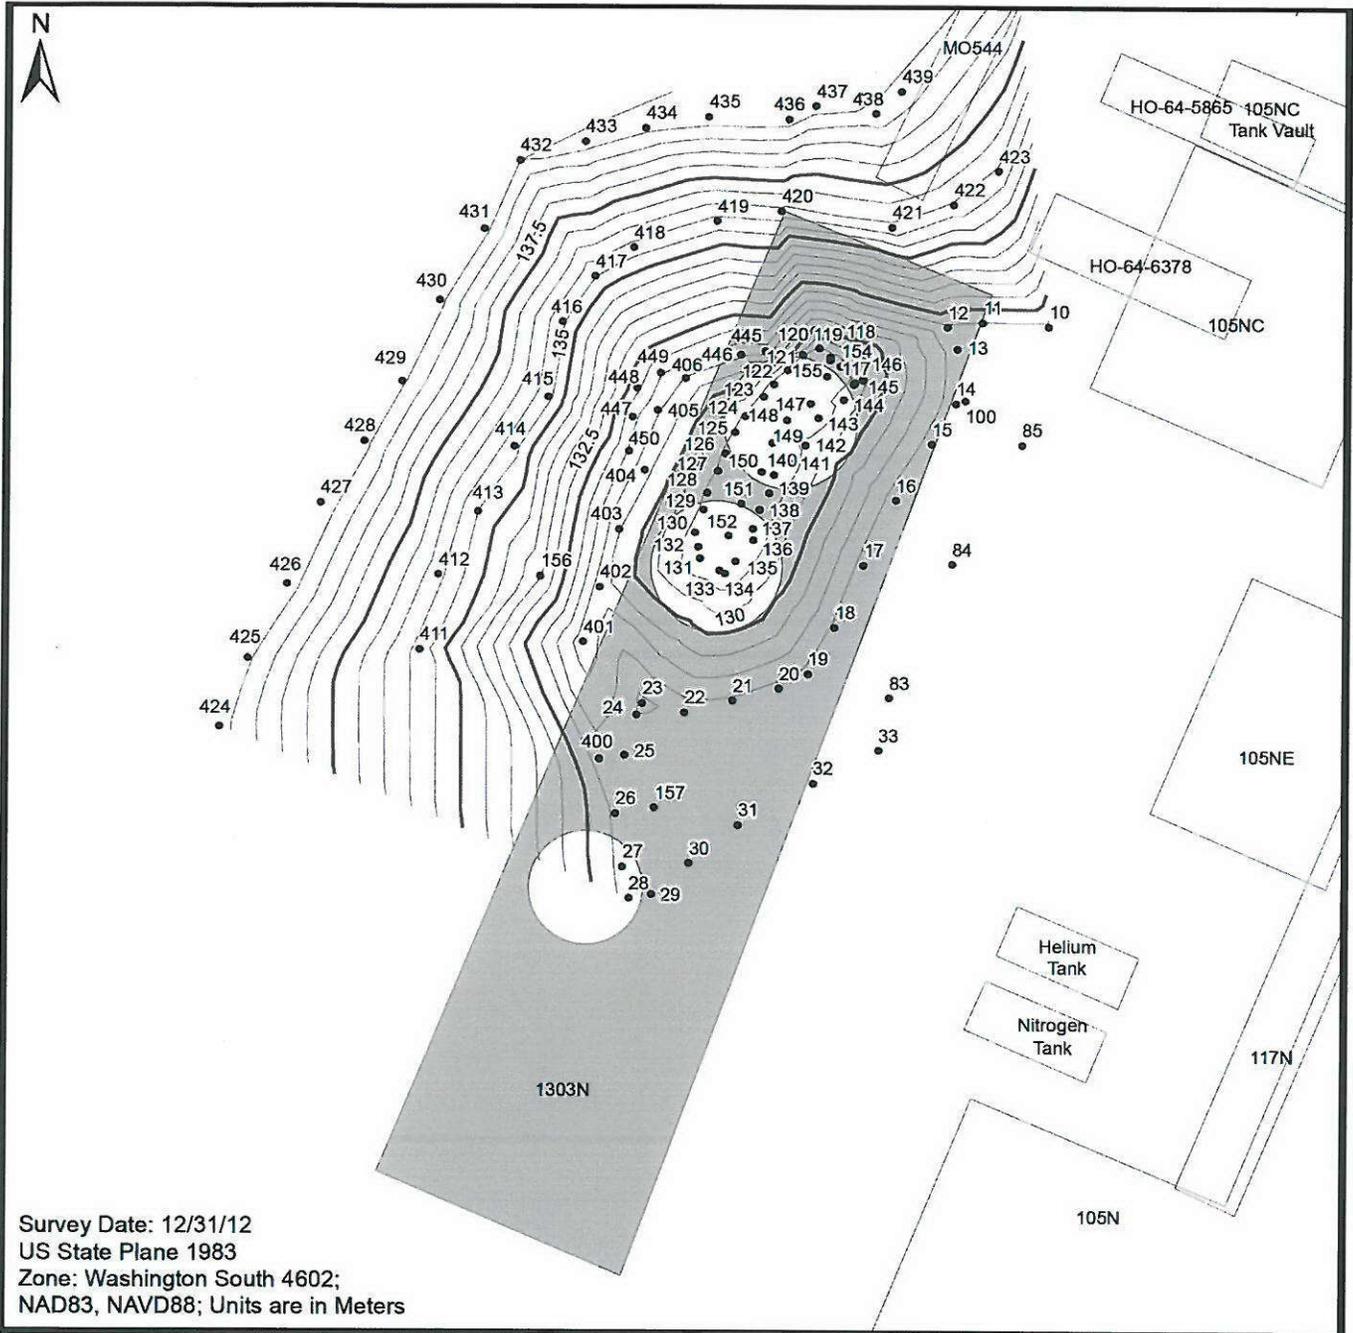
## GPS Pre Demo Survey Report For 1303N Building

A pre-demolition Global Positioning System (GPS) survey was performed at the 1303-N Spacer Silos in April of 2010. A post-demolition GPS survey was performed at the 1303-N Spacer Silos excavation footprint in December of 2012. Copies of these GPS surveys are provided in Attachment 4.

- GPS Point Locations
  - Major Contour 2.5 Meter Interval
  - Minor Contour .5 Meter Interval
  - 1303N Building Location (Pre-Demo)
  - Historic Building Locations
- 0 5 10 20 Meters

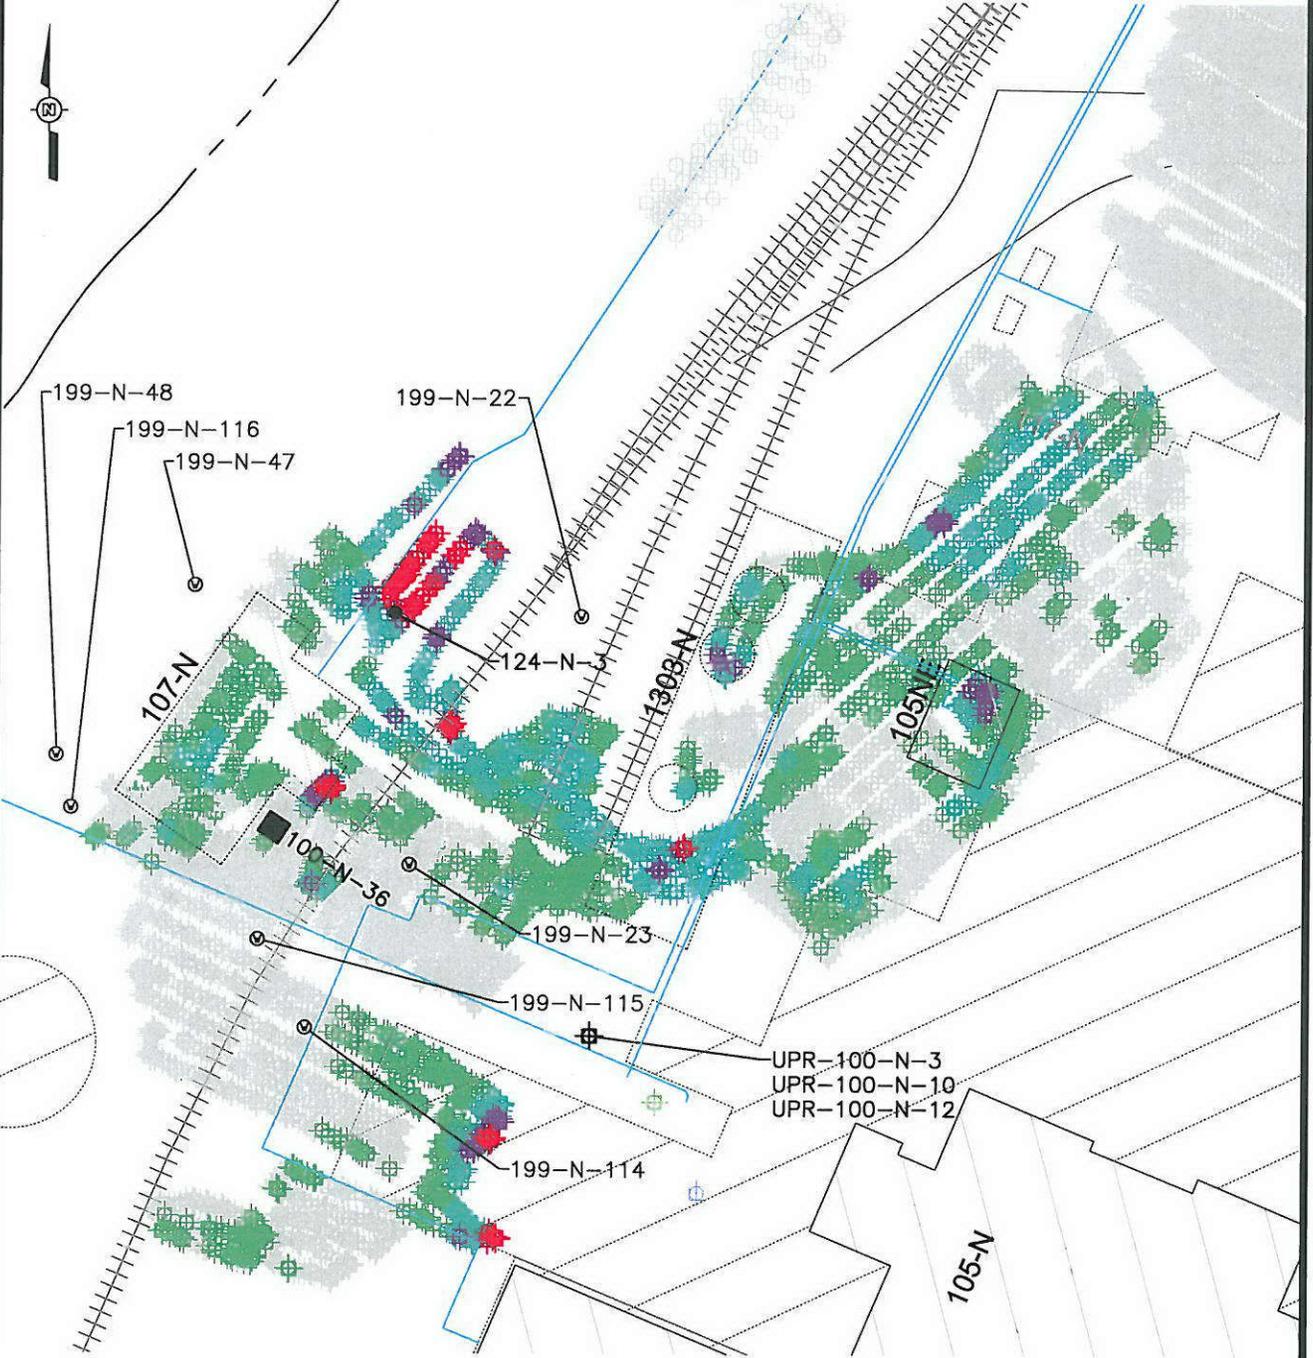
105/109N Westside  
Beta Composite  
Map

Paved Roads		
	Dirt Roads		<2 x Bkg
	Railroad Tracks		2 x Bkg - 5000
	Demolished Building		5000 - 10000
	Existing Building		10000 - 25000
	Decommissioned Wells		>25000
	100-N-63:2 Pipelines
